All Stretton Bunkhouse - Access Information.

1. Introduction.

4. Access Survey. i. Access Path and Entrance.

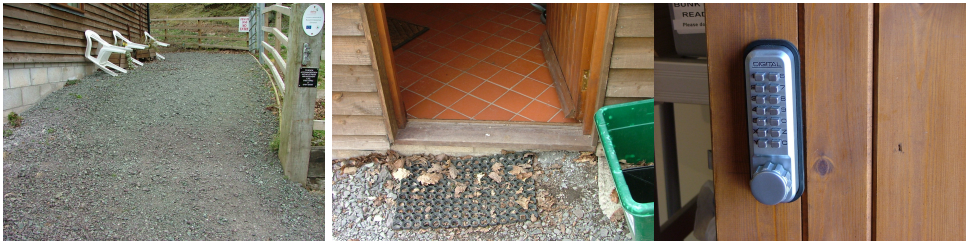
The path leading to the Bunkhouse is rough and steep. It is possible to drive up to the gateway, but it is best to reverse up to maintain traction and to avoid a difficult manoeuvre to decline. The path to the main door is firm, but some stones are larger than 5mm and loose. The first part of the path is reasonably level, then a short stretch of <1:6, before becoming > 1:20. The door width is 82cm and there is a step of 15cm leading into the bunkhouse. The Bunkhouse is accessed by a key code pad. Sensory planting could be provided near to the entrance to complement the sound of running water from the nearby stream.

- Provide a paved area to enable visitors to get out of vehicles on to a firm and level surface;
- Modify the slope to provide a path a minimum width of 150cm and not steeper than 1:20 where possible;
- Provide sensory planting to complement the sound of running water near to the doorway;
- Provide a hand rail alongside the pathway;
- Provide level access into the doorway or provide handrail;
- Highlight the key pad to make it more visible to people with visual impairments

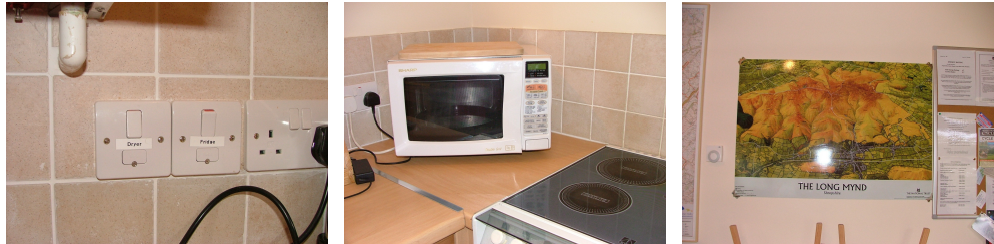
ii. Kitchen/Dining Room

The kitchen/dining room is light and airy and generally the space is clear and without clutter. The kitchen units are of a standard height and design (height – 90cm and depth 61cm). The taps and the sink unit are of a standard design. The white electrical sockets do not provide a colour/tonal contrast with the plugs. There is a kitchen table and chairs; the table height is 78cm and the clearance under the table when seated is 61cm. There are a range of kitchen appliances, including, microwave, oven, tumble dryer, refrigerator. There is not a pan guard on the cooker which would be a generally useful safety measure and may be particularly helpful to blind and visually impaired users. The microwave is positioned so that it is necessary to reach over the cooker hob to operate it. There is some information and signage in the kitchen area, but none in “alternative format” minimum large print 14 point although 20 point is preferred by some people with visual impairments. Although only a relatively small percentage of blind people read Braille, labels can be produced fairly inexpensively and could be provided to identify key safety features and essential items such as electrical sockets powering individual appliances. There is also a large wall map which covers the Long Mynd area. This could be easily and cheaply provided in a tactile map format. People with learning disabilities often prefer to have visual images rather than written and therefore it would be useful to liaise with MENCAP to discuss how graphic images might be presented within the Bunkhouse.

The reception for mobile telephones is variable from the building and so a payphone facility is provided. The dial and receiver is 105cm from the floor level. As the kitchen area is the general meeting and social area for guests it would be helpful to people who are hard of hearing and use hearing aids to provide a portable audio induction loop in this area. The RNID will provide technical advice and specifications www.rnid.org.uk . A flashing and audio fire alarm system should be considered if visitors with hearing impairments are likely to stay at the Bunkhouse, the Fire Officer will provide additional advice on this point.

- Provide clear colour/tonal contrasts to highlight electrical sockets and plugs to benefit users with visual impairments;
- Move the microwave to a convenient location so it is not necessary to lean across the cooker to operate it;
- Provide a cooker pan guard on the cooker and ensure that controls are easy to use;
- Consider labelling sockets, cupboards and draws with Braille signage - Kitchen - general safety – good practice to clearly label with symbols knife draws and other potential hazards;
- Provide information is large print – minimum of 14 point for body text and 20 point for notices and consider providing a tactile map of the area;
- Consider providing flashing and audio fire alarm system and hearing support induction loop system.

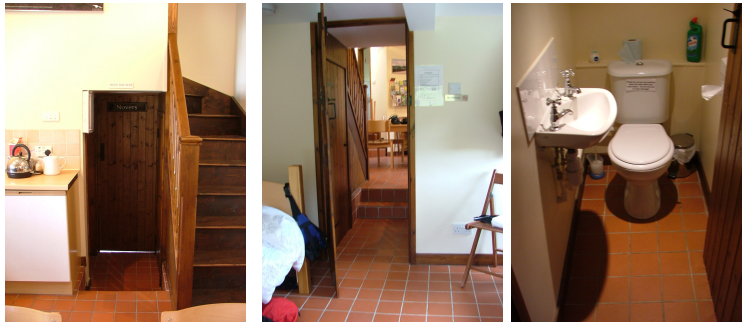
Novers Bedroom.

There are three steps leading from the kitchen to the Novers bedroom. The terracotta tiles in the kitchen continue throughout, including the steps into the bedroom. This means that there is not a colour/tonal to distinguish the steps from the general floor space. The width of the steps is approximately 58cm and there is a sign advising users to beware of the lower than average portal height. There is a separate toilet and washroom next to the Novers bedroom which has standard fittings. The sink height is 74 cm.

- Consider edging the steps to provide a colour/tonal contrast
- Provide a tactile mat at the top and bottom of the steps
- Provide a handrail alongside the wall
- Ensure that low head notice is provided in large print.

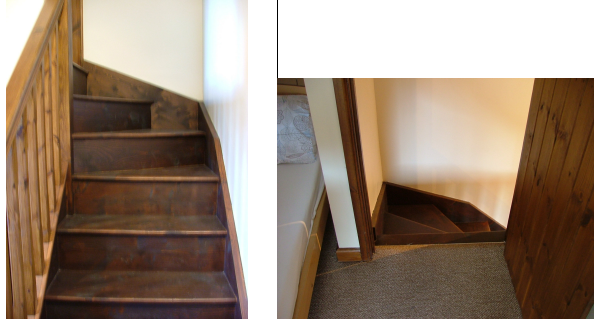
Caradoc Bedroom.

There are nine steps along dog leg staircase which lead to the Caradoc. The steps are 74cm wide. There is not a full handrail on the staircase. The bedroom door opens directly onto the staircase.

- Provide colour/tonal contrast to highlight step edges
- Provide hand rail on stairs
- Provide safety notice to advise guests that doorway leads directly onto staircase
- Provide tactile mats at entrance to stairs

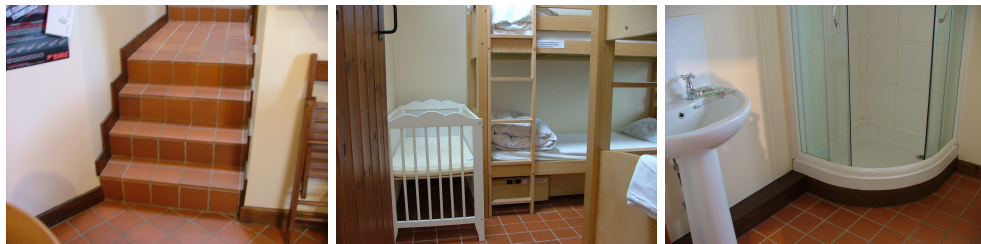
Synalds and Shower Room,

There are three steps to the landing with access to the shower room and a further two more steps to the Synalds bedroom. The steps are 78cm wide and each step is 16cm deep. There is not a handrail on the staircase. The terra cotta tiles extend from the kitchen and some people with visual impairments may find it difficult to visualise individual steps. There are two sets of bunk beds and child's cot in the room. The lower bunks are 50cm and the upper bunks 107cm from the floor.

The shower room has standard fittings with a step in shower unit. The chrome taps do not contrast well with the white sink and walls and a colour/tonal contrast might be provided to highlight them and to distinguish the hot and cold taps.

- Provide a handrail on the steps
- Provide a colour/tonal contrast to distinguish the edges of the steps
- Provide a colour/tonal contrast on the bathroom fittings to assist people with visual impairments
